FINAL REPORT JANUARY 1992

REPORT NO. 91-12

TRANSPORTABILITY TESTING OF COMMERCIAL CONTAINER IMPROVED DUNNAGE METHOD

U.S. Army Defense Ammunition
Center and School
ATTN: SMCAC-DET
Savanna, IL 61074-9639

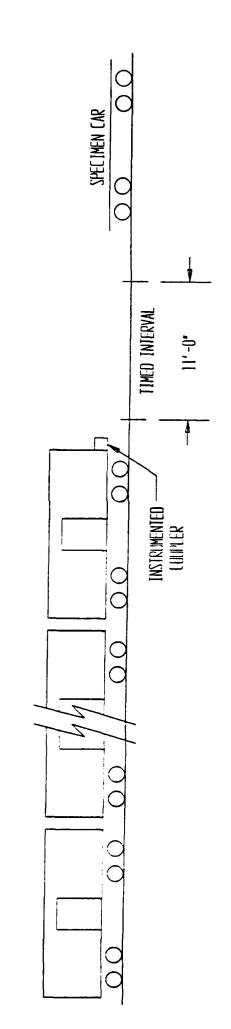
FIGURE 1

A. RAIL IMPACT TEST. Each container test load was positioned directly on the locking pedestals of the railcar. Equipment needed to perform the test included the specimen (hammer) car, five empty railroad cars connected together to serve as the anvil, and a railroad locomotive. These anvil cars were positioned on a level section of track with air and hand brakes set and with the draft gears compressed. The locomotive unit pulled the specimen car several hundred yards away from the anvil cars and, then, pushed the specimen car toward the anvil at a predetermined speed, disconnected from the specimen car approximately 50 yards away from the anvil cars and allowed the specimen car to roll freely along the track until it struck the anvil. This constituted an impact. Impacting was accomplished at speeds of 4, 6, and 8 mph in one direction and at a speed of 8 mph in the opposite direction. The 4 and 6 mph impact speeds are approximate; the 8 mph speed is a minimum. Impact speeds are determined by using an electronic counter to measure the time required for the specimen car to traverse an 11-foot distance immediately prior to contact with the anvil cars (see figure 1).

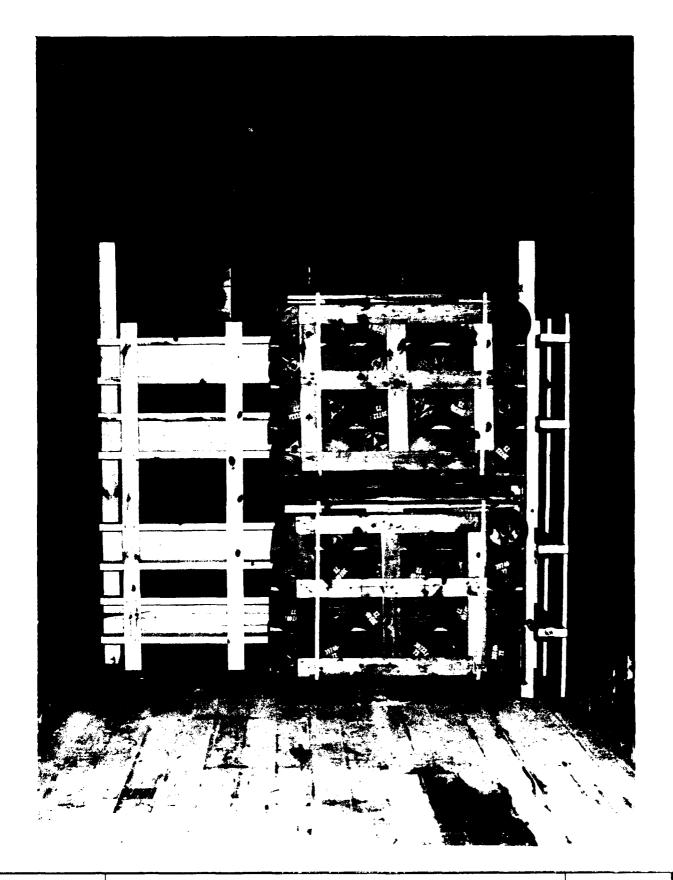
The first impacts were done with the door of the container facing the anvil cars. No damage was noted with this test load. During the second impact, approximately 1/8-inch bowing of one of the door supports resulted. The fourth impact showed slightly more bowing. Only 1-inch total void developed at door end after the fourth (reverse) impact.

Photo No. AO317-SCN-91-200-3234. This photo shows the forward portion of the load for the first test load.

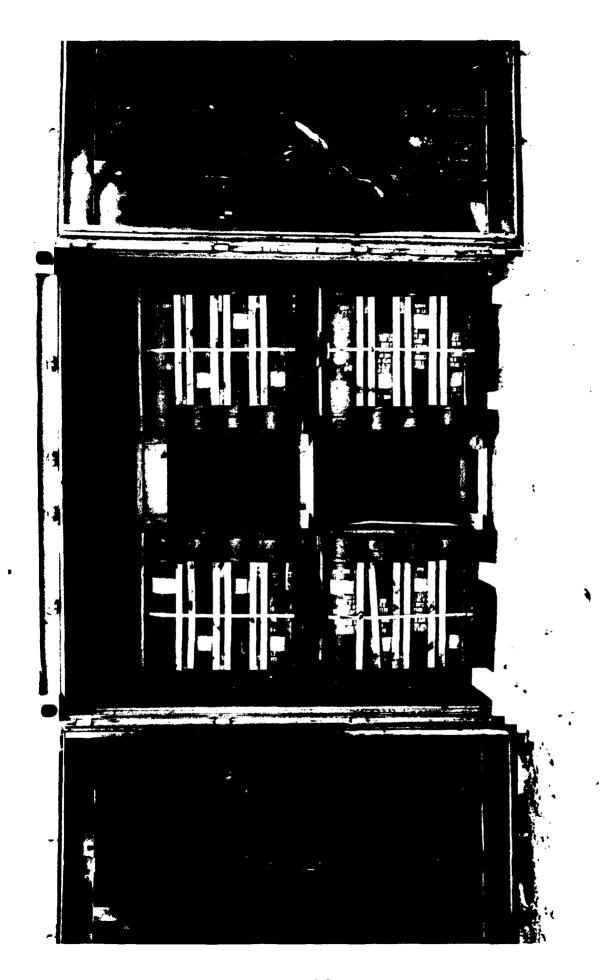
Photo No. AO317-SPN-91-200-3228-91. This photo shows the completed load for the first test load. U.S. ARMY DEFENSE AMMUNITION CENTER AND SCHOOL - SAVANNA, IL

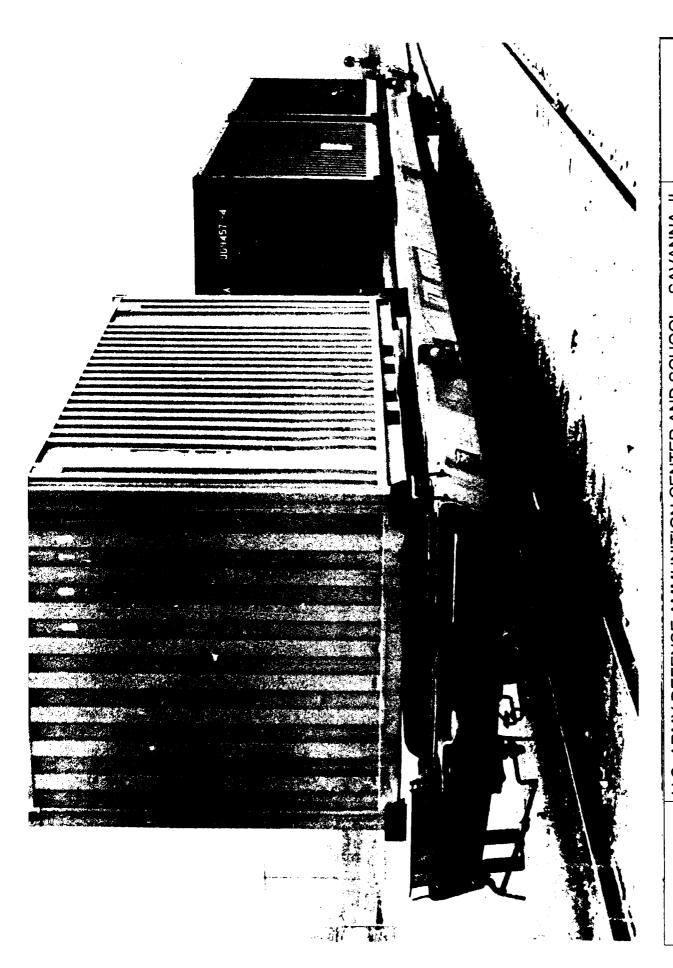
Photo No. AO317-SCN-90-200-3206. This photo shows the rail car configuration used during rail impact tests. U.S. ARMY DEFENSE AMMUNITION CENTER AND SCHOOL - SAVANNA, IL
